XIAC CF1220 Memory Flap Unit Installation/Validation (v1.0 – January 2016)

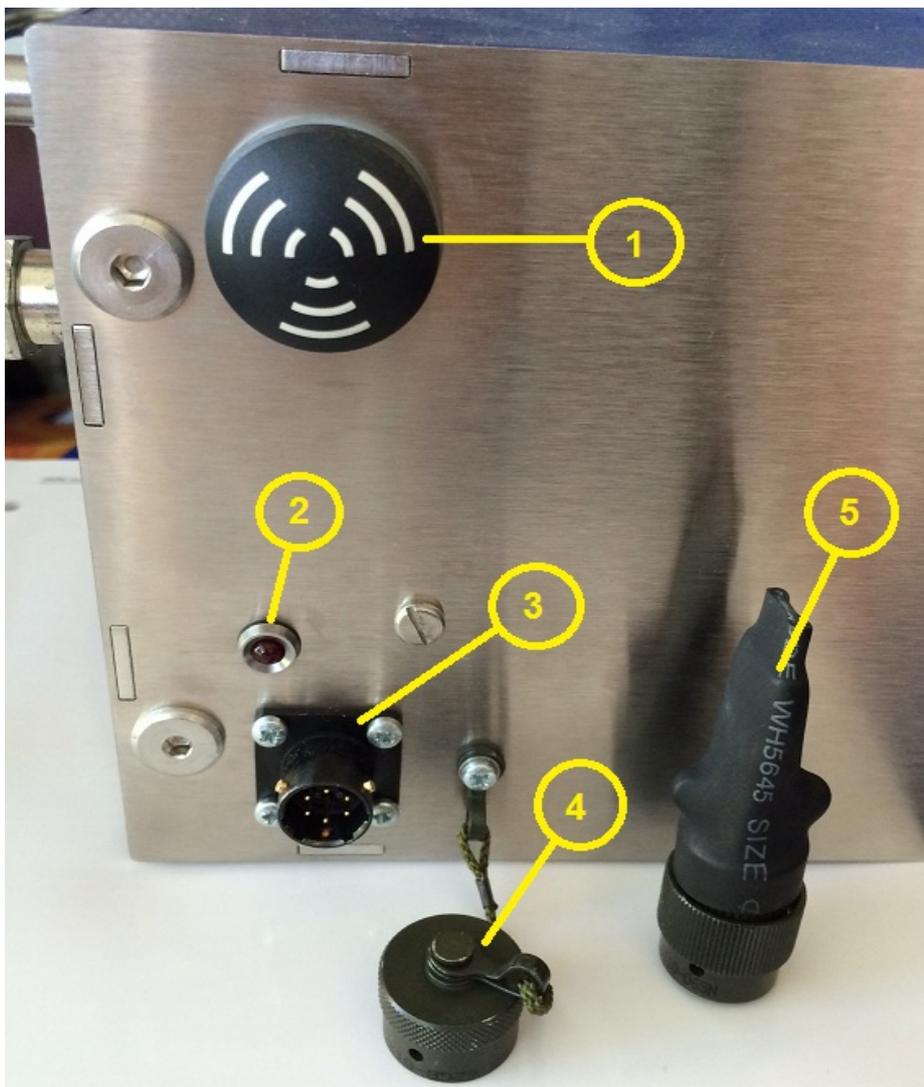
On the back of the unit we find a few items that were not present on the OEM unit.

1. Audible signal indicator / Beeper
2. Optical signal indicator / LED
3. Connector for Bluetooth dongle
4. Dust cap (replace when connector not in use)
5. Bluetooth dongle (required for iPhone app)

When at least one of the measured cylinder timings is out of the set minimum and maximum range, an audible signal will sound and an optical signal will indicate the channel in error. The optical signal will also flash when the air pressure is low (no audible signal will sound).

Audible signal: Will output a specified number of beeps when a channel is in error. The number of beeps can be changed through the iPhone app. The signal is approximately 80dB, this is not very loud and will not cause any discomfort to the ears even when the front doors (that usually cover the MFU) are open.

Optical signal: The LED will flash in a binary (morse code style) fashion to indicate the faulty channel. A short flash (dit) is indicated by a dot (".") and a long flash (dah) by a dash ("-"). The duration of the dits and dahs are chosen so that they are easily recognisable for most people. They keep repeating (separated by a long pause) until the channel is no longer in error.

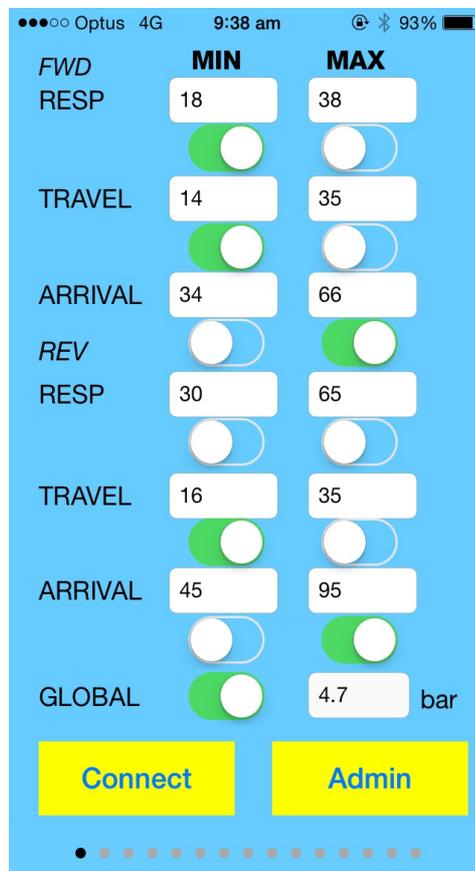
As can be seen in below screenshot, not all errors are enabled. The errors for the timings that will not influence the accuracy of the count are not enabled. This is done so that the cylinders can be used without problem for the longest possible time.

Note that the air pressure indicated (4.7 Bar) has a tolerance of about 10%

FWD RESP (forward response time). If a cylinder responds too quick, the memory flap may bump into a previous product and change its direction. Worst case would be that it would catch the product onto the memory flap rather than letting it pass. Very unlikely to happen, but enabled never-the-less.

TRAVEL (forward travel time). If the travel time is too short, the cylinder moves too fast and could bounce when the buffer is hit.

ARRIVAL (forward arrival time). If the memory flap does not reach the end within the required time, it could miss catching a product and an overcount/undercount situation may occur.

REV RESP (reverse response time). This time does not influence the accuracy of the count and therefore error checking is disabled by default.

ARRIVAL (reverse arrival time). If the memory flap does not return home within the required time, it could be commanded forward while not all products on the flap have passed through to the bottle resulting in miscounted bottles.
